**Flood Control Project Maintenance
Levee Inspections**

Maintenance Issue Types Only, Levee Inspection Report By Mile - Fall 2015

Reclamation District No. 0307 Lisbon

Waterway	Bank	Unit Miles	Inspection Start/End	Inspector
Unit No. 01 Sacramento River	Right	6.56	10/14/2015 10/14/2015	Herman Phillips

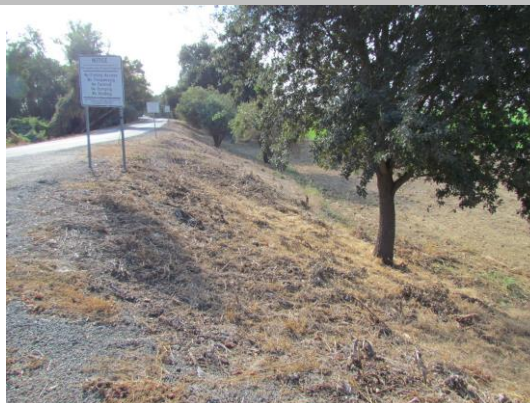
Photo 1 of 1 : FA_2015_RD0307_166_62_20151019_00033.jpg

LM Start	0.00	Rating **	A	Issue No.	62
LM End	6.56	Issue Type +	Ma	Location *	LS
Category	Earthen Levee			GPS Latitude/Longitude	
				Start	End
Item	Vegetation			38.480023 °	38.429775 °
				-121.549420 °	-121.533370 °
DWR ID	DWR_RD0307_01_f_2015_62				
Action/Comments					
Control annual grass and weeds on the levee slopes and easements. Inspector Comments: The RD has done a great job removing unwanted vegetation from the landside levee slope.

Looking downstream from levee mile 0.00 land side slope.

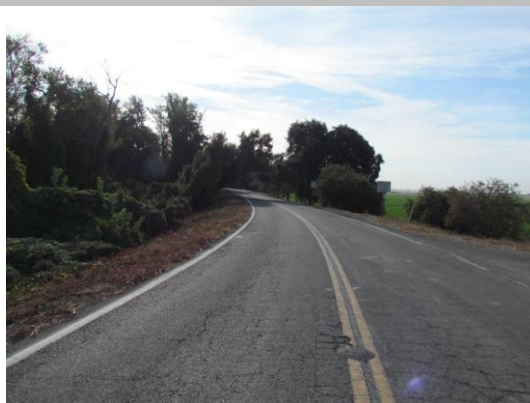
Photo 1 of 1 : FA_2015_RD0307_166_63_20151019_00032.jpg

LM Start	0.00	Rating **	A	Issue No.	63
LM End	6.56	Issue Type +	Ma	Location *	WS
Category	Earthen Levee			GPS Latitude/Longitude	
				Start	End
Item	Vegetation			38.480023 °	38.429775 °
				-121.549420 °	-121.533370 °
DWR ID	DWR_RD0307_01_f_2015_63				
Action/Comments					
Control annual grass and weeds on the levee slopes and easements. Inspector Comments: The RD has contracted for the levee slopes to be cleared of unwanted vegetation from levee mile 0.00 thru 6.65 waterside.

Looking downstream from the waterside levee slope levee mile 0.00.

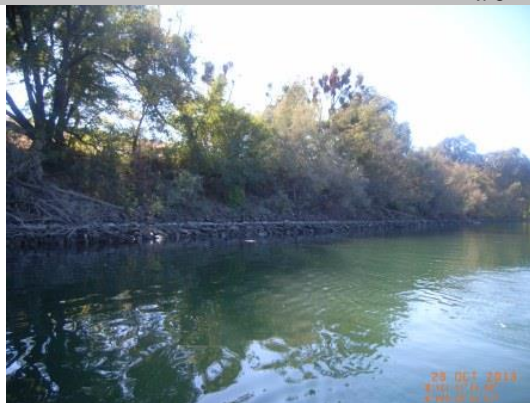
Photo 1 of 1 : USACE2013A_SAC_48-6_R_4.jpg

LM Start	1.17	Rating **	M	Issue No.	1
LM End	1.31	Issue Type +	Ma	Location *	WS
Category	Supplemental			GPS Latitude/Longitude	
				Start	End
Item	2015 USACE Erosion Survey, DRAFT			38.473059 °	38.473082 °
				-121.530988 °	-121.528437 °
DWR ID					
Action/Comments					
Inspector Comments: 2012 - Bank is slowly eroding, old rock protection starting to unravel. 2015: No observed changes. [2015 Site ID: SAC_48-6_R]

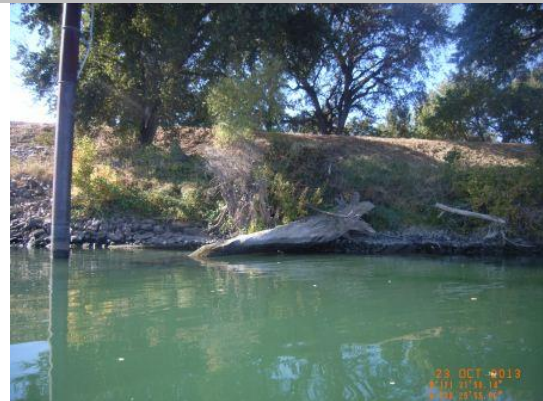
Photo 1 of 1 : USACE2013A_SAC_43-2_R_5.jpg

LM Start	6.19	Rating **	M	Issue No.	2
LM End	6.38	Issue Type +	Ma	Location *	WS
Category	Supplemental			GPS Latitude/Longitude	
				Start	End
Item	2015 USACE Erosion Survey, DRAFT			38.434560 °	38.432287 °
				-121.531159 °	-121.532978 °
DWR ID					
Action/Comments					
Inspector Comments: 2008 - Large rotational failure in bank and well into the levee slope. Could be a significant problem in the next high flow event. 2009 - Minimal new erosion, site extended upstream. 2010 - Minor new erosion. 2011 - Tree popout has left a large hole. Large slump area. Rock on the bank is failing in some locations. 2012 - The toe appears to be scouring out. 2015: No observed changes. [2015 Site ID: SAC_43-2_R]

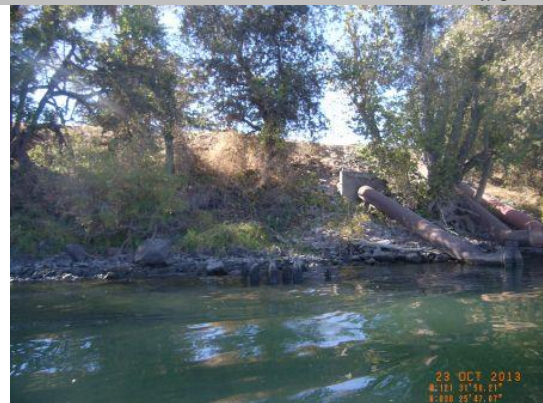
Photo 1 of 1 : USACE2013A_SAC_43-1_R_6.jpg

LM Start	6.42	Rating **	M	Issue No.	8
LM End	6.55	Issue Type +	Ma	Location *	WS
Category	Supplemental			GPS Latitude/Longitude	
				Start	End
Item	2015 USACE Erosion Survey, DRAFT			38.431726 °	38.429957 °
				-121.533200 °	-121.533035 °
DWR ID					
Action/Comments					
Inspector Comments: 2011 - Erosion pockets likely from tree popouts. This site has been in the inventory before and been fixed with emergency bank rock but continues to fail. 2015: No observed changes. [2015 Site ID: SAC_43-1_R]
